Summary of findings from the test you must make client aware of. Turbomister quote this test on their website so they acknowledge it as ok.

EES Problems and Issues

5.2 Enhanced Evaporator Issues

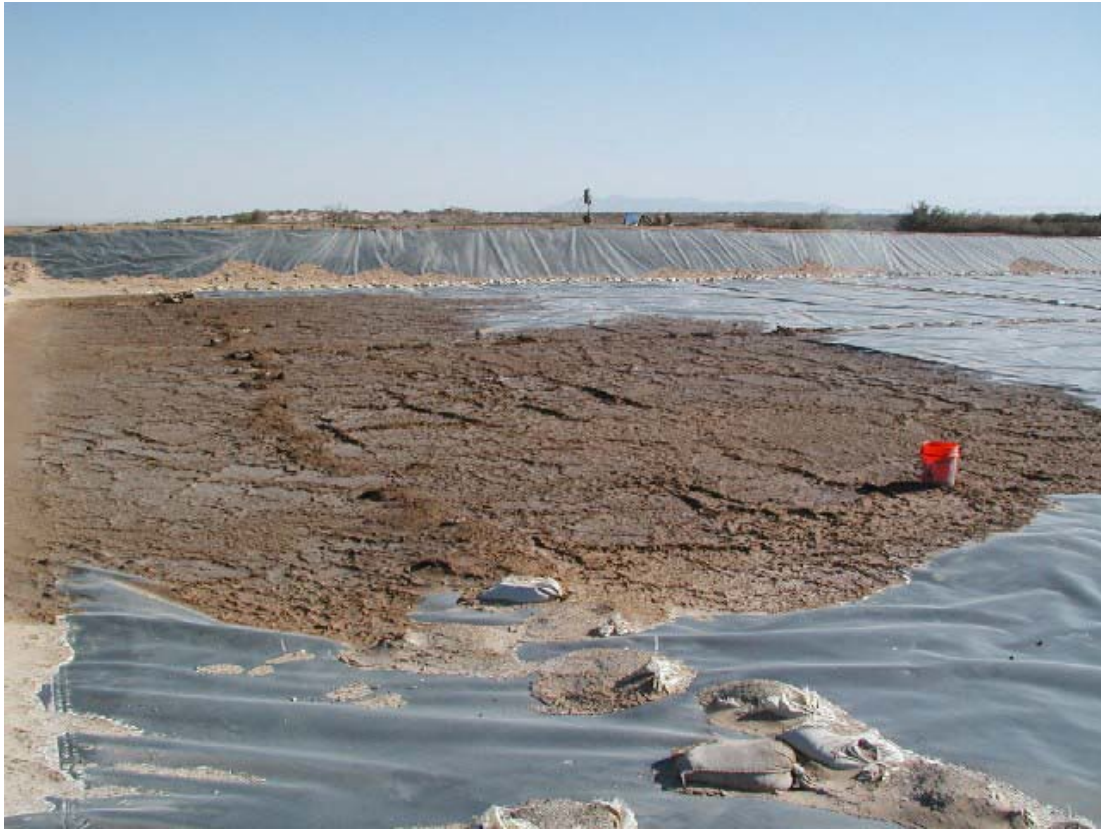
Figure 5.7—Bitterns after 3 months of evaporation at Salton Sea Test Base

The heaviest brines produced at the Test Base were those left in the disposal pond sump after the EES pre-test that was conducted in 2001. This test produced a thin layer of salts in the disposal pond and the quantity of entrained brines was relatively small. These brines drained towards the sump, where they evaporated over a period of months. These highly concentrated bitterns were pumped to the pond cell. The bitterns were moved before new saturated brines were pumped

into the disposal pond from EES and solar ponds. Over a period of weeks, nearly all the bitterns were evaporated and precipitates were formed. Although not completely dry, and when mixed with the blowing sands that are omnipresent at the Test Base, the materials were more of a firm mud with an oily consistency than a liquid state. The final characteristics of the bitterns did not change beyond this muddy-like consistency.

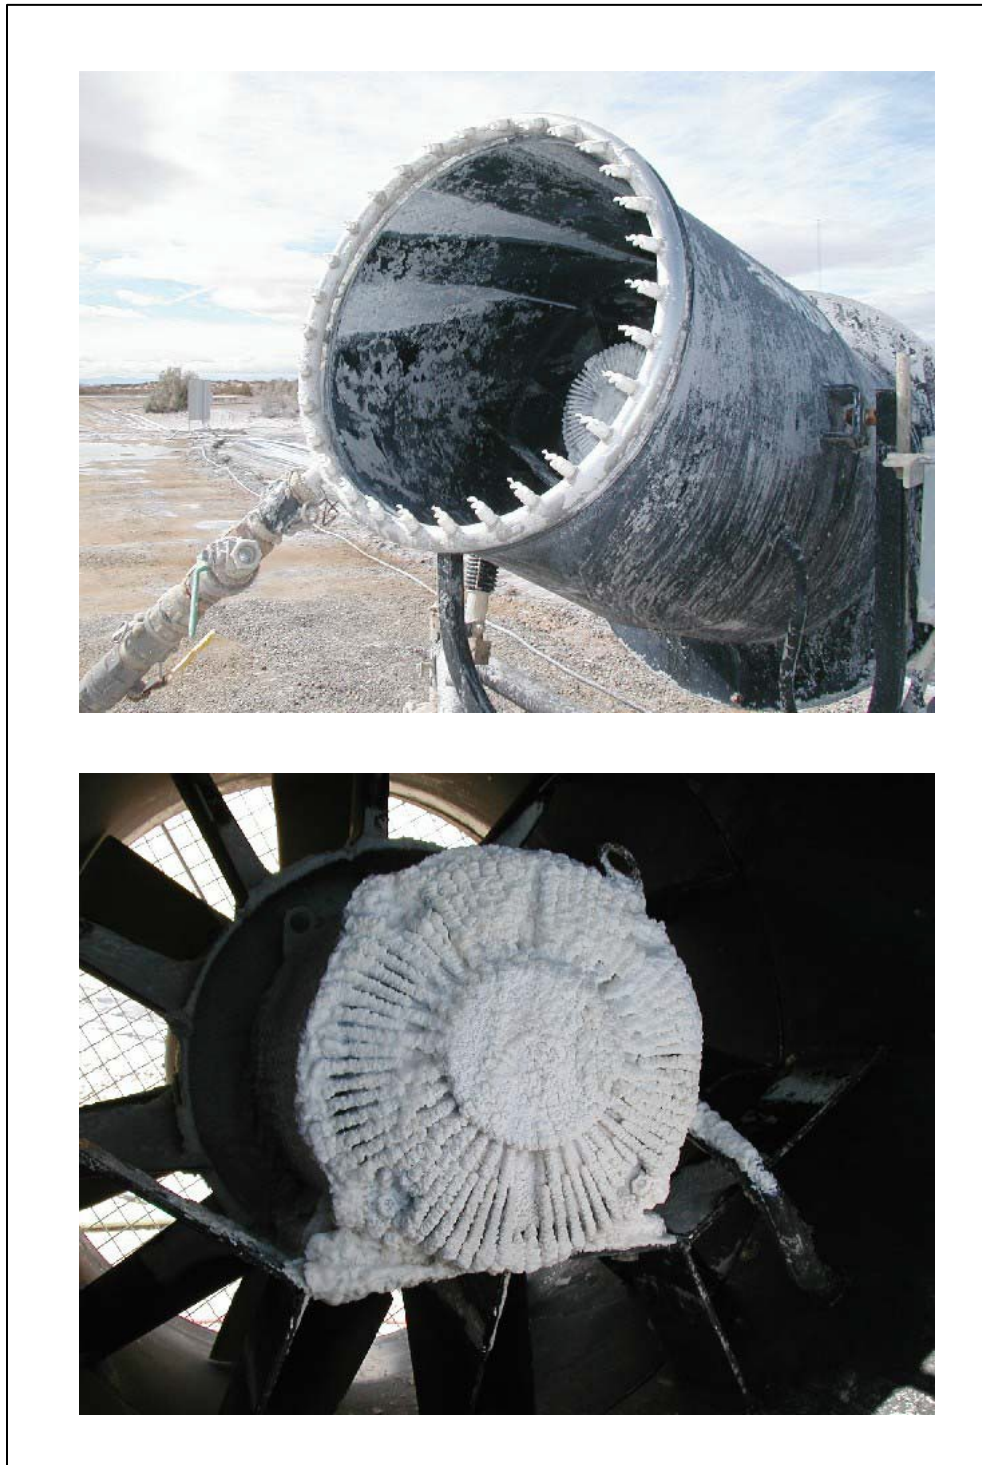
Figure 5.8—Salt deposits on evaporators from mist ingestion.

- Page 75 Mist fouling of the evaporators was a major problem. Any wind from a non- aligned direction resulted in mist surrounding the units. Much of the mist was sucked into the impellers of the turbo fans, resulting in deposits like those shown in figure 5.8. Left unattended, enough mist could be ingested into the units to force the impeller blades out of balance. The devices had to be shut down every couple of days and pressure washed, both inside and outside of the housings. This

Mist fouling of the evaporators was a major problem. Any winds at all from a nonaligned direction resulted in mist surrounding the units, and much of it was sucked into the impellers of the turbo fans. Left unattended, enough mist could be digested into the units to force the impeller blades out of balance. The devices had to be shut down every couple of days and pressure washed both inside and outside of the housings. This process was time consuming and was an endless task in the course of project operations.

Mist fouling of the evaporators was a major problem. Any wind from a non-aligned direction resulted in mist surrounding the units. Much of the mist was sucked into the impellers of the turbo fans, resulting in deposits like those shown in figure 5.8. Left unattended, enough mist could be ingested into the units to force the impeller blades out of balance. The devices had to be shut down every couple of days and pressure washed, both inside and outside of the housings. This process was repetitive and time consuming over the course of project operations.

To reduce the possibility but not completely eliminate the risk of mist digestion by the EES units, it would be necessary to robotically slave each of the EES units to multiple wind direction, wind speed, and wind shear detection systems. Any fouling by mist digestion by a significant number of EES units would be very expensive and time consuming to clean up. For a project forecasted to include hundreds, if not thousands, of these units, such a cleanup event would require thousands of hours of labor.

To reduce, but not completely eliminate, the risk of mist digestion by the EES units, each EES unit would need to be robotically slaved to multiple wind direction, wind speed, and wind shear detection systems. Any fouling by mist digestion by a significant number of EES units would be very expensive and time consuming to clean up. For a project forecasted to include hundreds, if not thousands, of these units, such a cleanup event would require thousands of hours of labor.
